## **Test Report**

**Determination of resistance  
to root damage to flexible sheets and coatings for  
roof planting according to FLL-method (2002)**

**Bituline EP 400 Antiracine**

**Date: 2006-02-14**

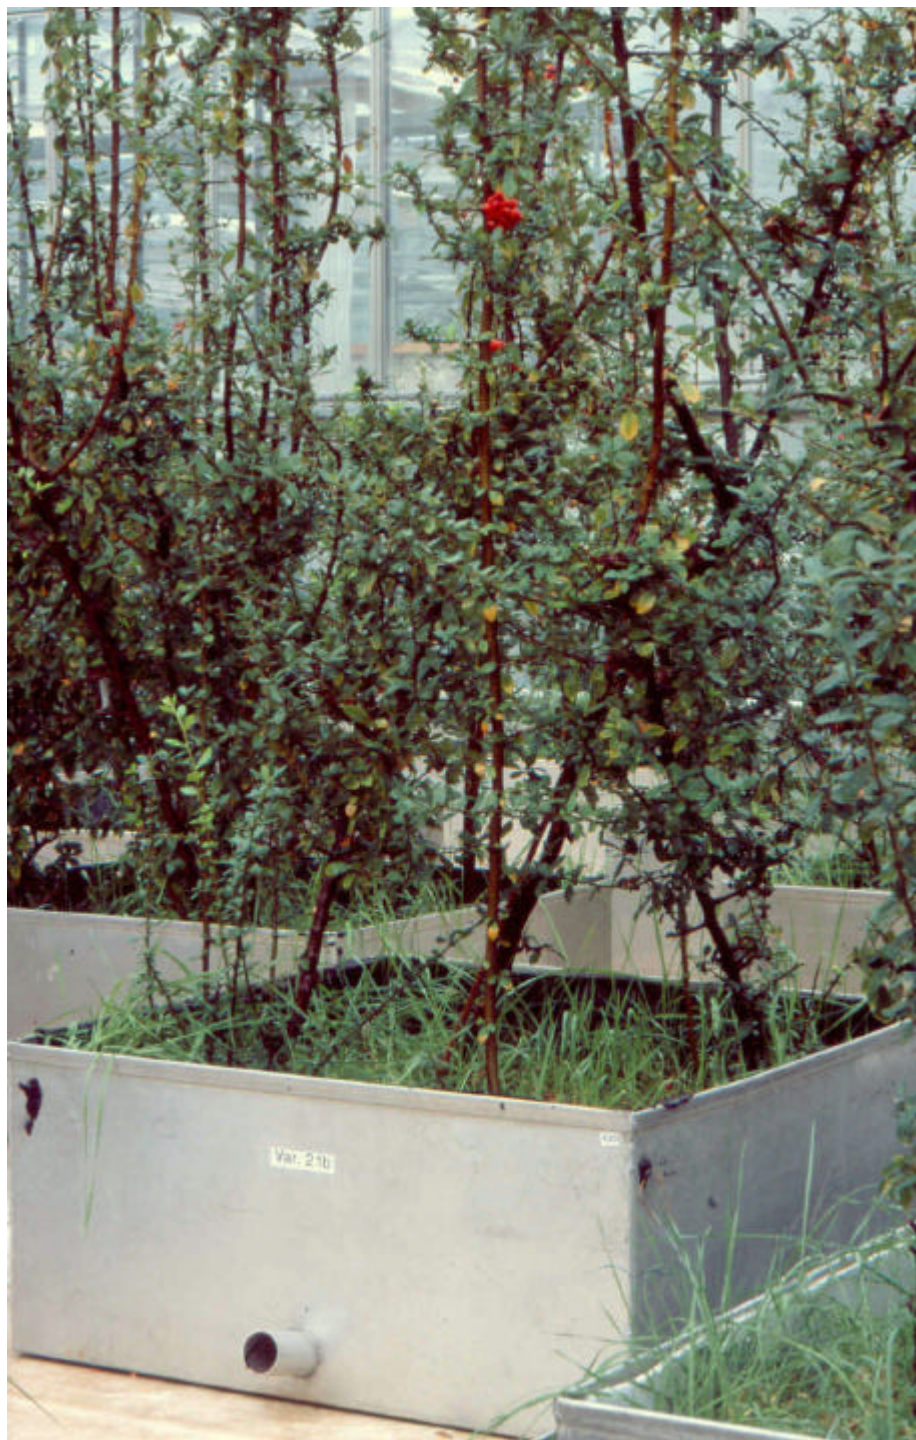
Figure 1: Test containers

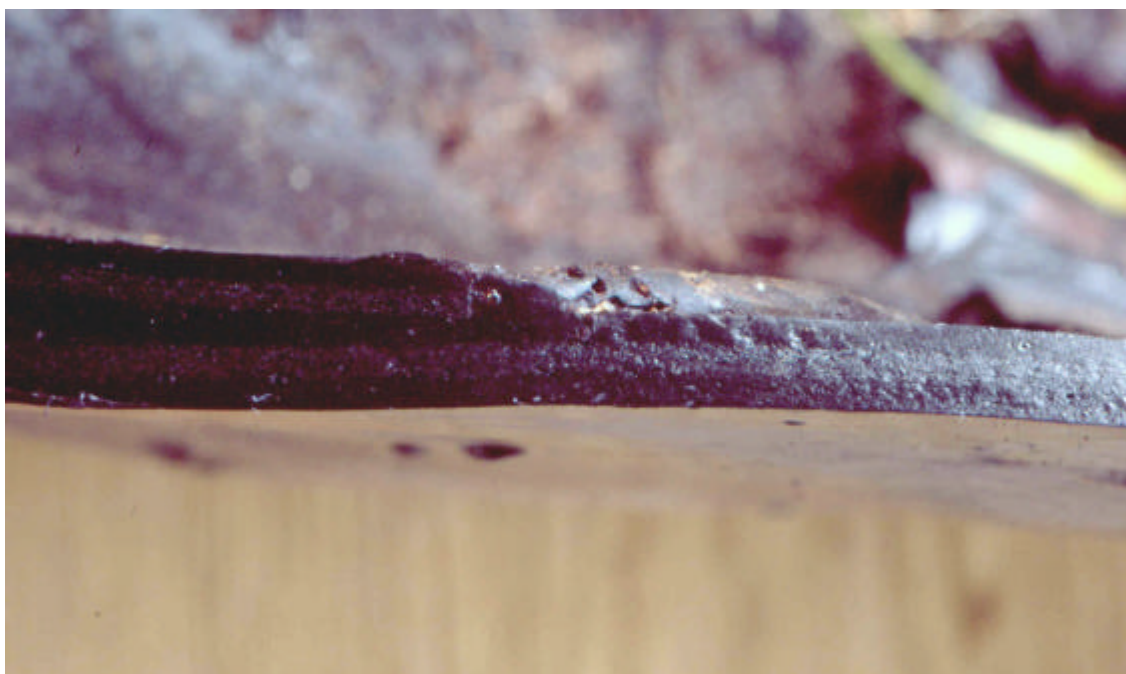
**Figure 3: Cut through joint**

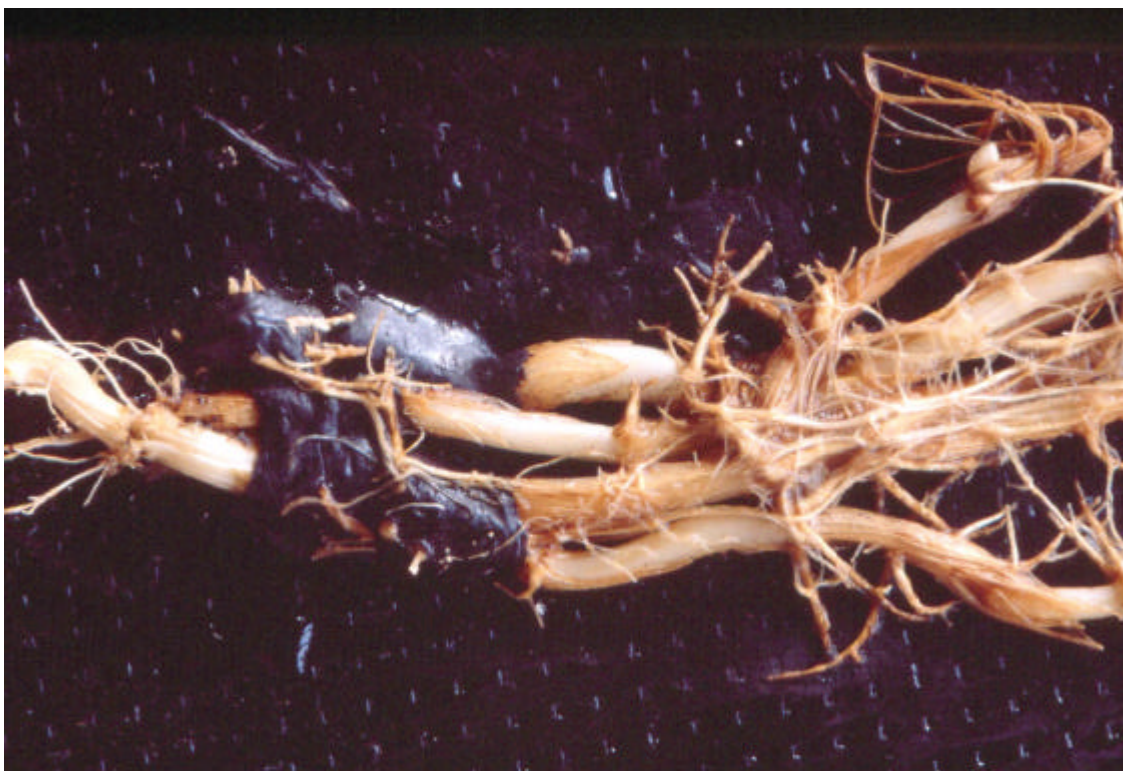
Some rhizomes had grown into the upper layer of the sheet without damaging the internal polyester felt. The penetrating rhizomes did in some cases grow several centimetres under the upper bitumen layer of the sheet along the polyester felt. Thereafter the rhizomes usually penetrated the upper bitumen layer again in the direction of the growing substrate.

**Figure 4: Sheet surface with penetrated rhizomes**

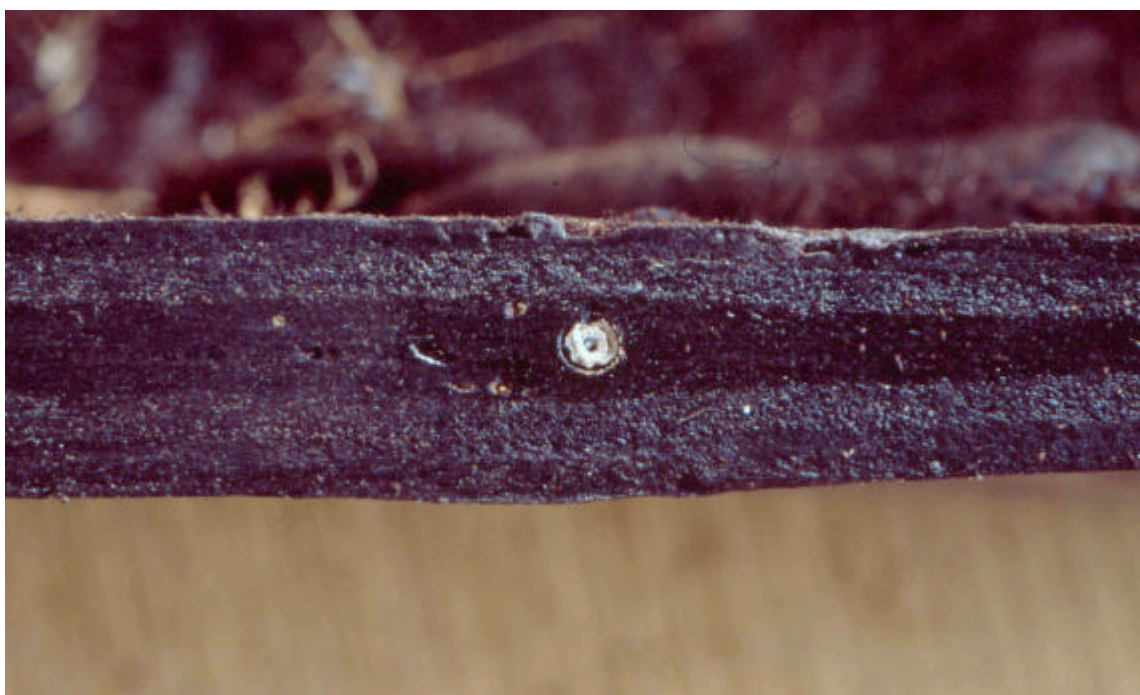
A few rhizomes did penetrate the seems up to a depth of 18 millimetres.

**Figure 5: Cut through joint with a penetrated rhizome**
